RAISING THE CEILINGS IN A Whole-House Remodel

Thanks to a good plan, a sizable crew, and a bunch of 20-ton screw jacks, the walls of this house grew taller

by David Morgan

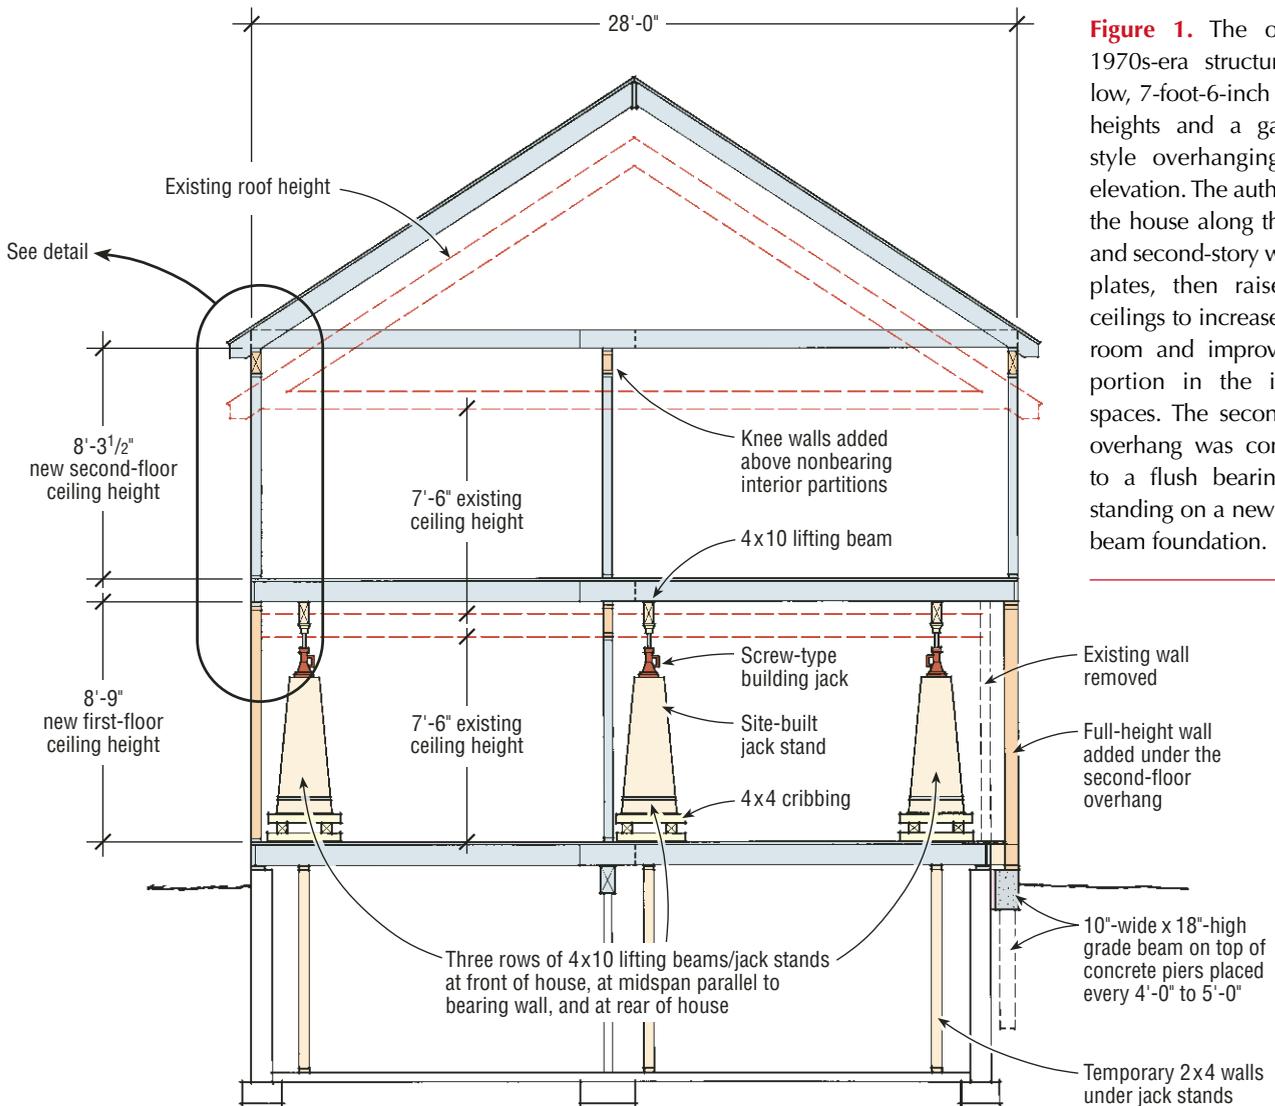
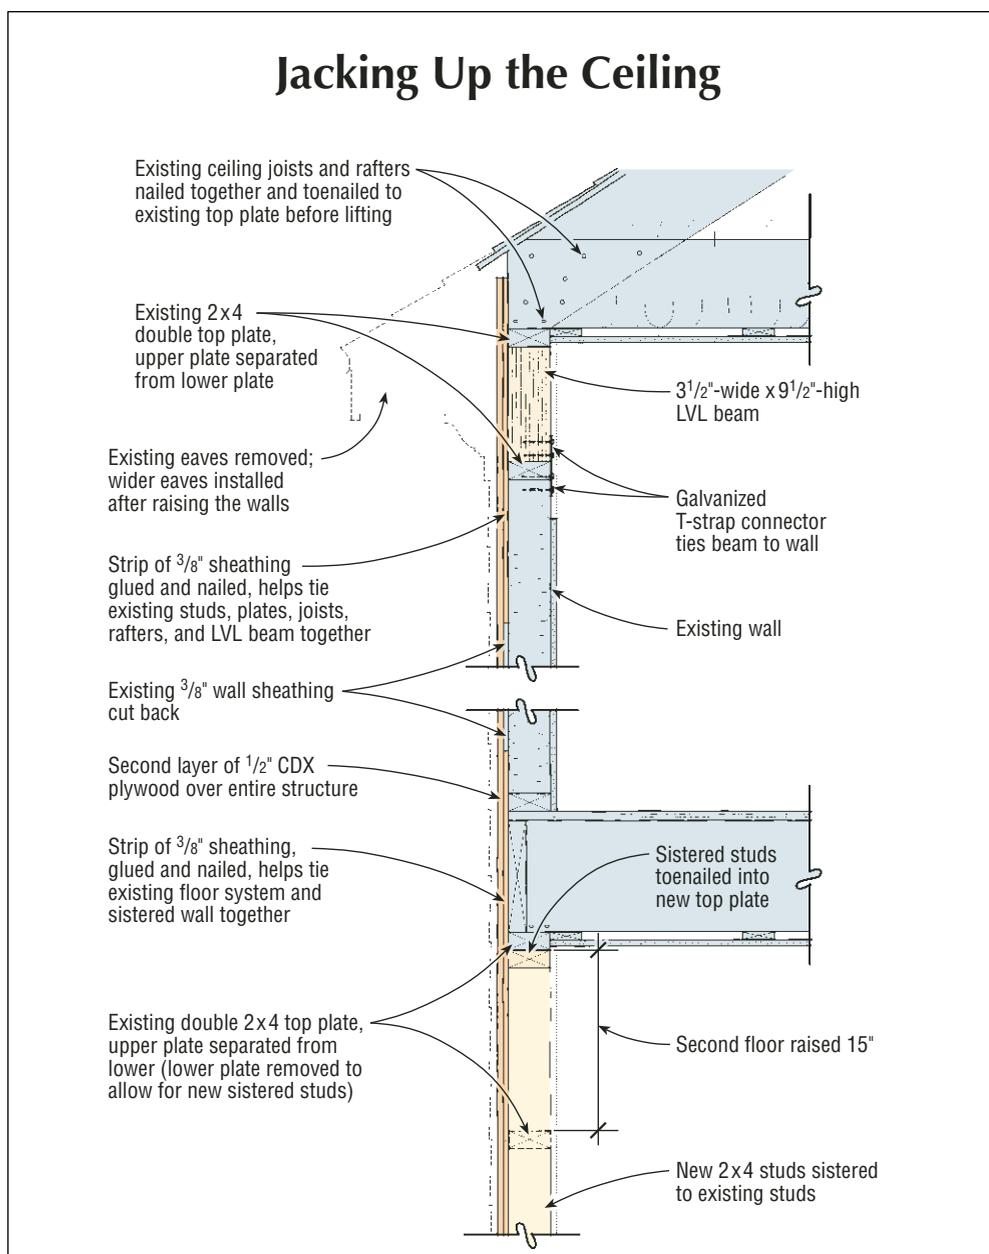
Figure 1. The original 1970s-era structure had low, 7-foot-6-inch ceiling heights and a garrison-style overhanging front elevation. The author split the house along the first- and second-story wall top plates, then raised the ceilings to increase head-room and improve proportion in the interior spaces. The second-floor overhang was converted to a flush bearing wall standing on a new grade-beam foundation.

We began by removing a 12-inch-high strip of plaster at the top of all the second-floor walls (see Figure 1, on this page and continued on page 3). We then drove a flat bar between the two 2x4 top plates and cut the nails with a recip saw. This left the ceiling joists, rafters, and top-plate assembly intact, saving time and maintaining structural integrity.

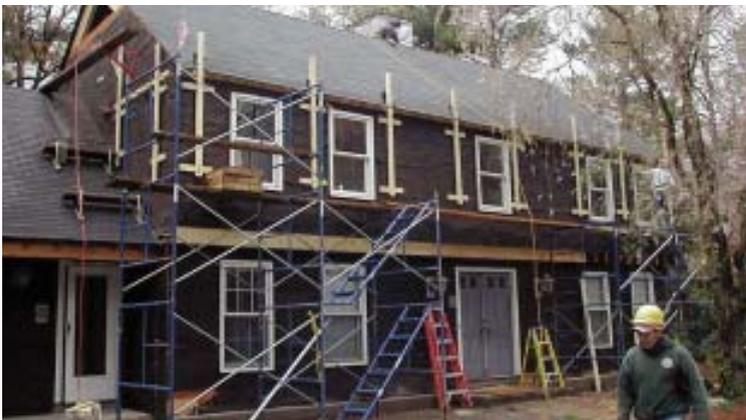
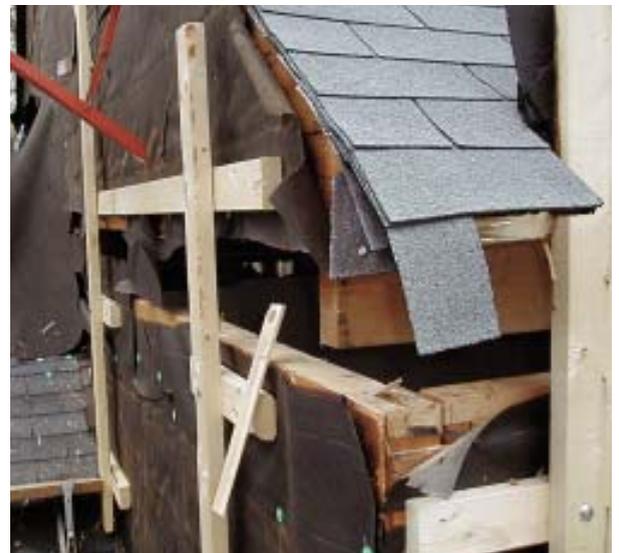
Figure 2. To maintain the original alignment and prevent the roof structure from shifting during lifting, the author's crew bolted 2x4 vertical struts to the tops of the walls around the house's perimeter.

A major concern was making sure that the roof would stay square, plumb, and aligned over the top plates during lifting. If it was not carefully restrained, we could have trouble placing the raised section back where it belonged. We solved the problem by through-bolting 2x4s vertically to the tops of the exterior walls around the entire perimeter of the house (Figure 2, next page). We notched the overhanging

roof sheathing directly above to provide slots for the 2x4s, so that they'd trap the roof above the walls and keep it from twisting in the wind or wracking out of alignment during the jacking.

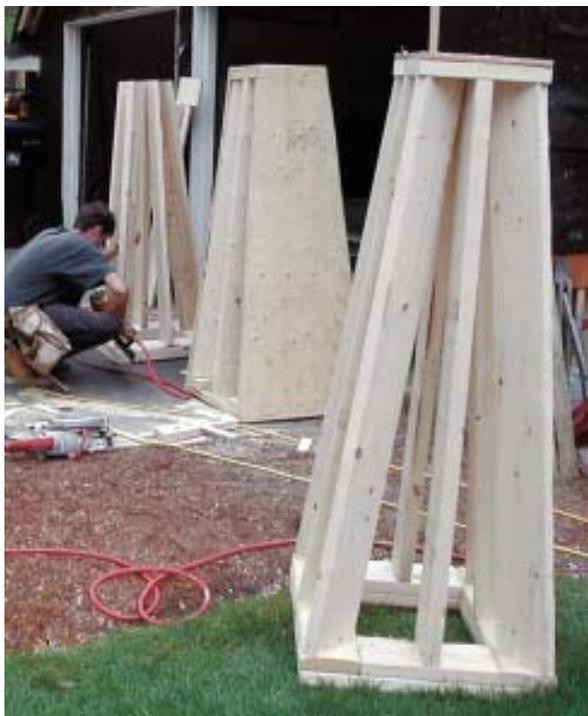
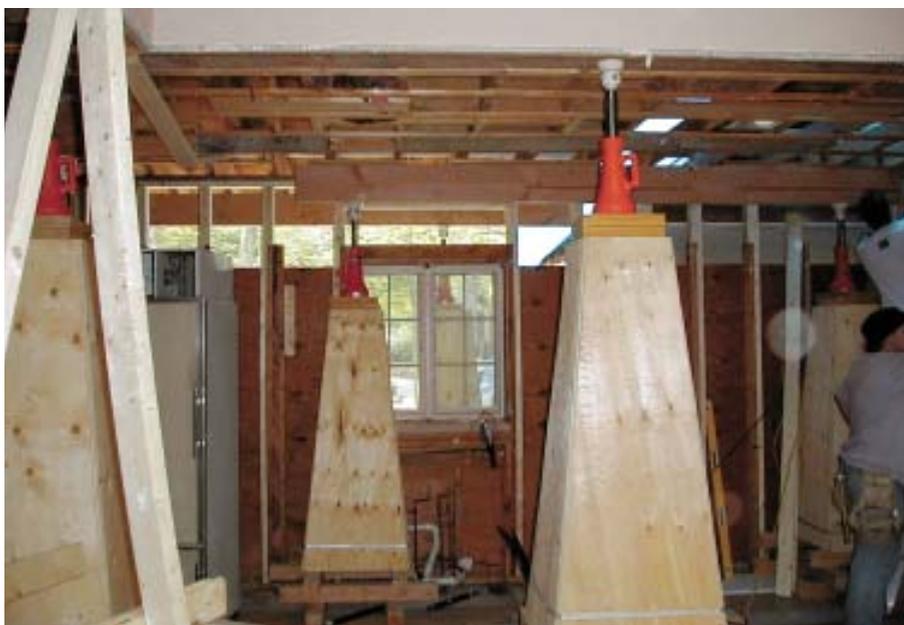
Figure 3. Site-built pyramidal jacking stands safely extended the screw jacks' reach to just below the lifting beams.

One of the early issues we had to decide was how to safely extend the reach of the screw jacks to the ceiling joists. My first thought was to place the jacks on the floor and use fir 4x4s or two 2x4s nailed together to prop under the 4x10 lift beams. But that presented a serious problem of stability — it would be easy for a post to kick out suddenly under a load, posing an unacceptable risk. We decided instead to build a quantity of structural pyramidal jack stands whose height could be supplemented as needed by stacking 4x4 cribbing under them. Some stands could serve as dead men, while others served as jack stations (Figure 3).

Pyramid stands. We made the stands by cutting 5-foot-long 2x8s at the requisite angle to taper from a 2-foot-square base at the bottom to a 1-foot-square top platform. We wrapped the sides, top, and bottom with $\frac{5}{8}$ -inch

plywood and screwed it with $1\frac{5}{8}$ -inch galvanized deck screws. As a final precaution, we wrapped a band of perforated, galvanized-steel strapping around the base about 8 inches up from the bottom and screwed through it into the studs with $2\frac{1}{2}$ -inch galvanized deck screws. In the unlikely event one or more studs failed under load, we figured the band would help keep the base from spreading.

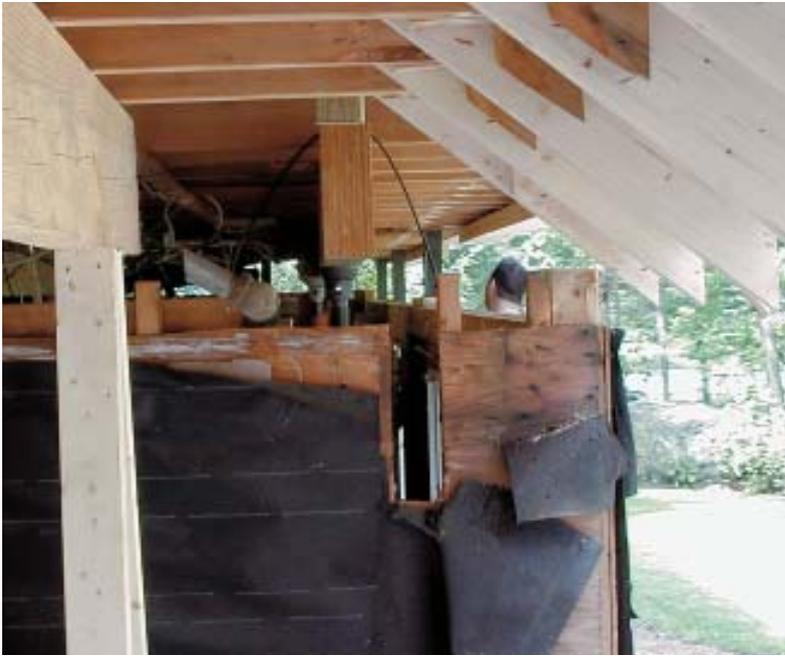
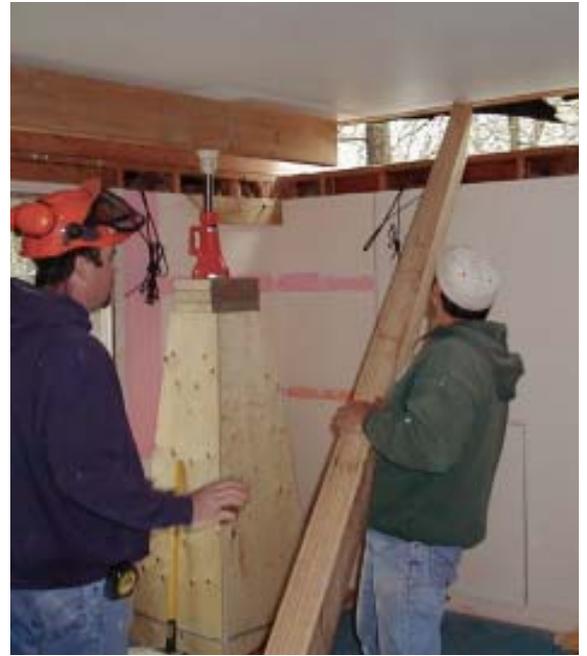
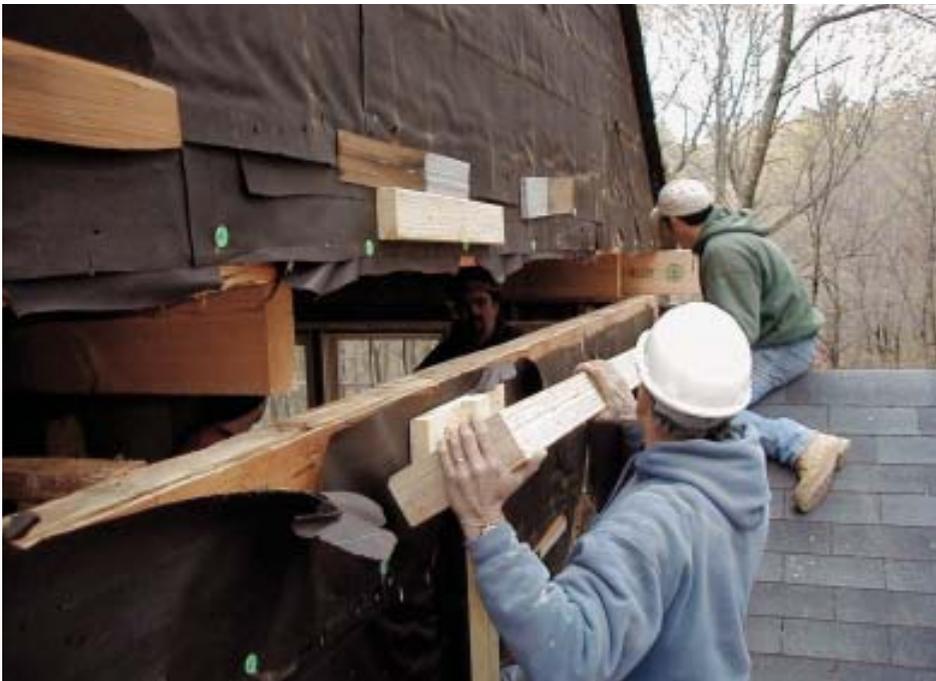
Figure 4. Working in small increments, the seven-man crew slowly raised the roof structure by 9 $\frac{1}{2}$ inches, allowing the nominal 4x10 engineered LVL plates to be inserted into position on top of the wall.

ments. We started with three rotations of each screw — about $\frac{5}{16}$ inch — across the front, then performed the same step at the middle and at the back. We repeated this sequence until we were able to set the beams on the lower top plate (Figure 4).

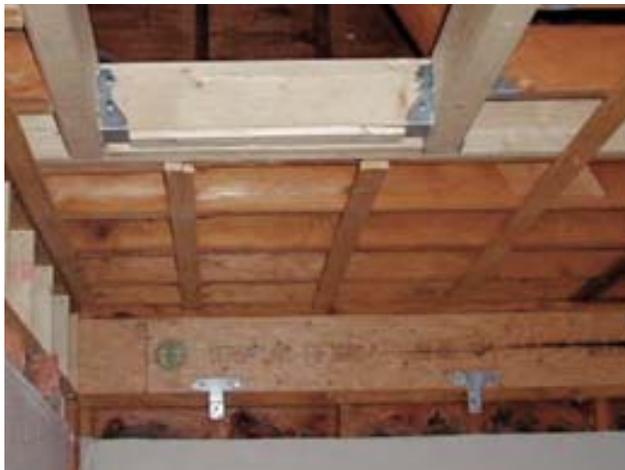
Figure 5. T-straps tie the LVL beam to the original plate at 16-inch intervals, helping to prevent the beam from rolling outward under lateral loads.

To consolidate the new and the existing framing, we cut back the plywood exterior sheathing about 15 inches down from its top edge and in-laid new, 2-foot-wide sheathing with glue and nails, tying together the existing studs, lower top plate, and LVLs. On the inside, we used 66T T-strap galvanized connecting plates (Simpson Strong-Tie, 800/999-5099, www.strongtie.com) to tie the bottom of the beams to the tops of the walls,

which would help prevent the beam from rolling under lateral wind loading or during a seismic event (Figure 5). The connecting plates caught the LVL beam along its bottom edge on 16-inch centers and were nailed into both the wall plate and the studs.

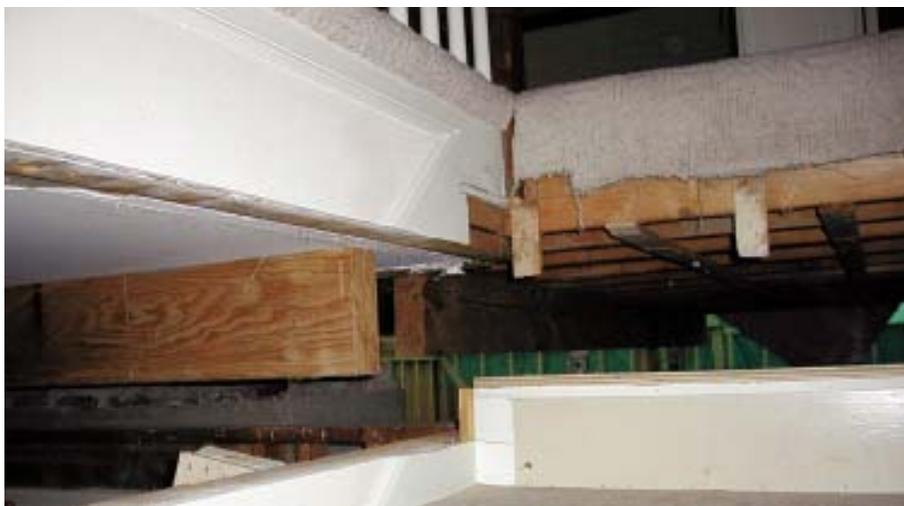
Figure 6. Though the staircase would be rebuilt, the original stair helped determine the distance that the first-floor ceilings were raised: two riser heights, or 15 inches.

We would be lifting the entire second floor — walls, roof, and all — a total of 15 inches. We settled on this height because the existing stair risers were a comfortable 7½ inches each. We decided that one riser wasn't enough and three would be disproportionate to the house. With a 15-inch rise, the new first-floor ceiling height would become about 8 feet 9 inches. Because the stair was more or less centrally located in the house, we had room on the first-floor level to elongate the flight by two treads. The stairwell remained unaltered, but we determined that it was best to build an entirely new staircase rather than supplement the existing one (Figure 6).

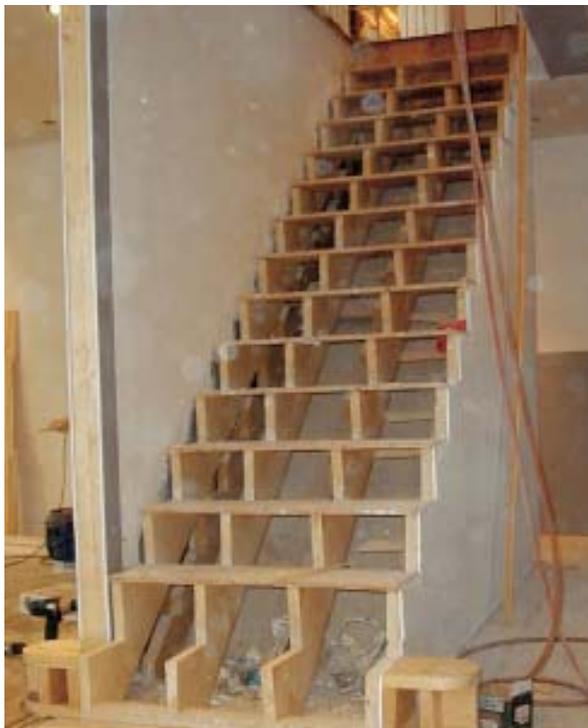
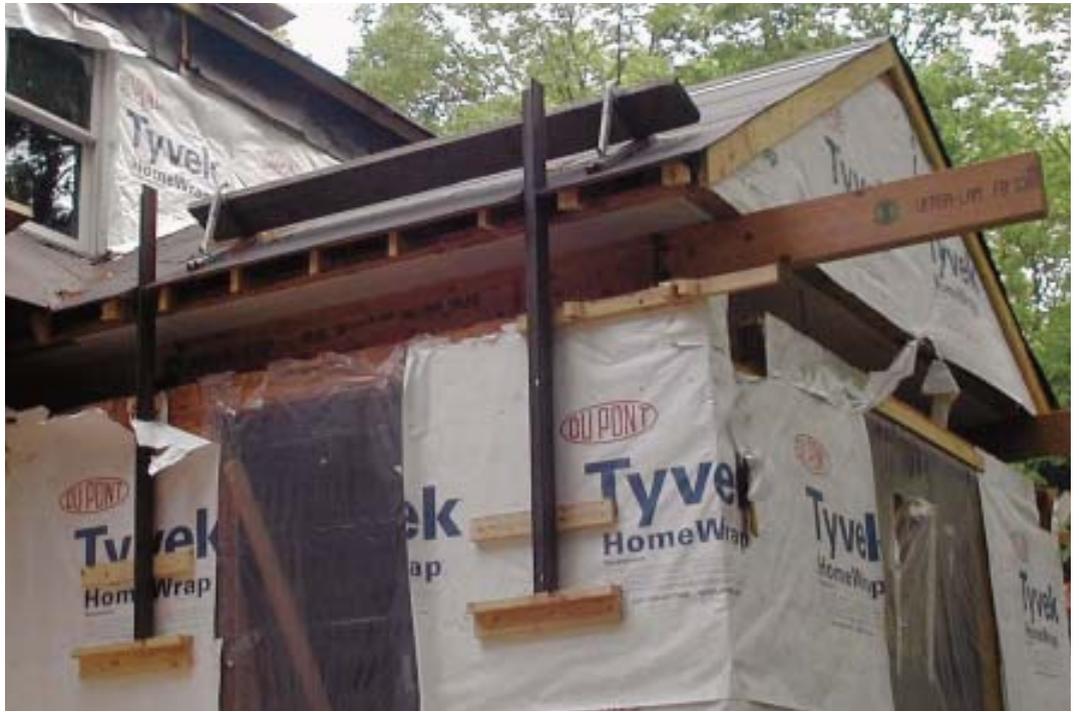
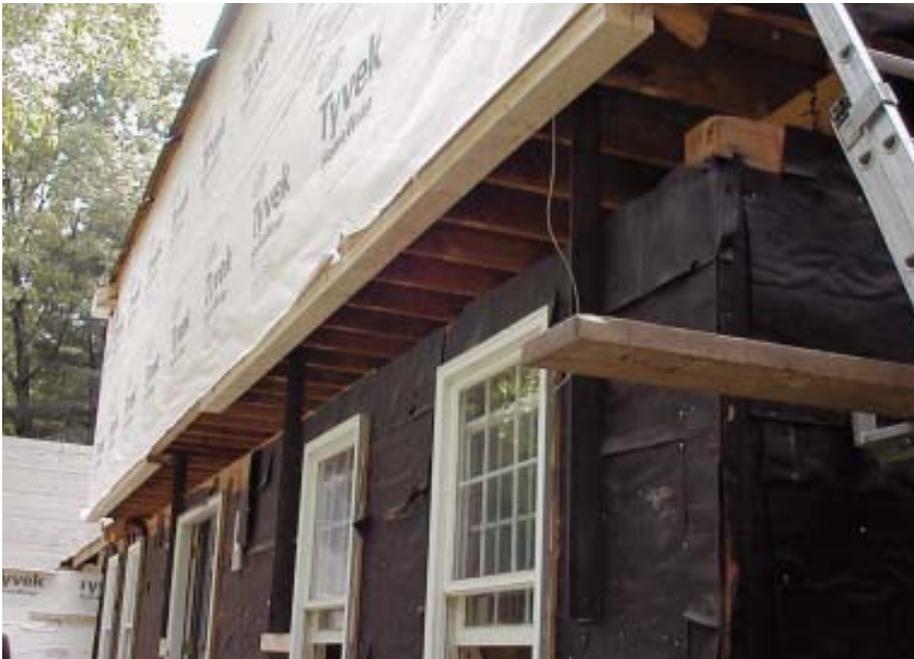
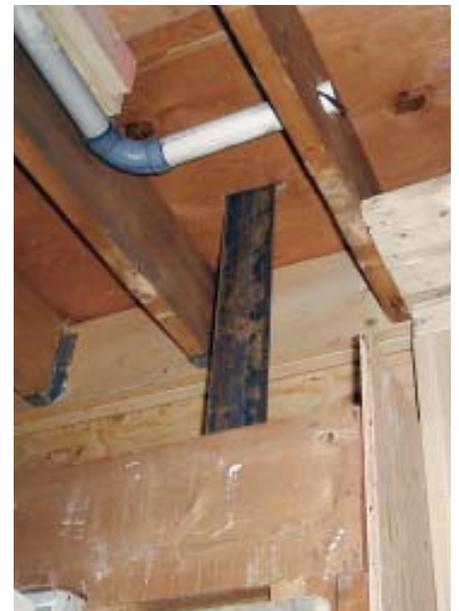
Figure 7. To prevent the upper story from being displaced when it was lifted, the author installed 4-inch steel angles to restrain it (above). At the overhanging front elevation (left), the crew cut L-shaped slots for the angles to pass through the second-story floor (below).

First, instead of using 2x4 retainers to prevent the building from moving out of alignment as it rose, we fabricated 7-foot lengths of 4-inch steel angle for that purpose (Figure 7, next page). We drilled holes for ½-inch through-bolts to pass through the wall, where they would be captured in the same way that sidewall staging brackets are mounted, with the capture

blocks spanning pairs of wall studs on the interior side. Instead of costly 10-inch or 12-inch carriage bolts, we bought much more economical 1/2-inch threaded rod and cut it to the lengths we needed.

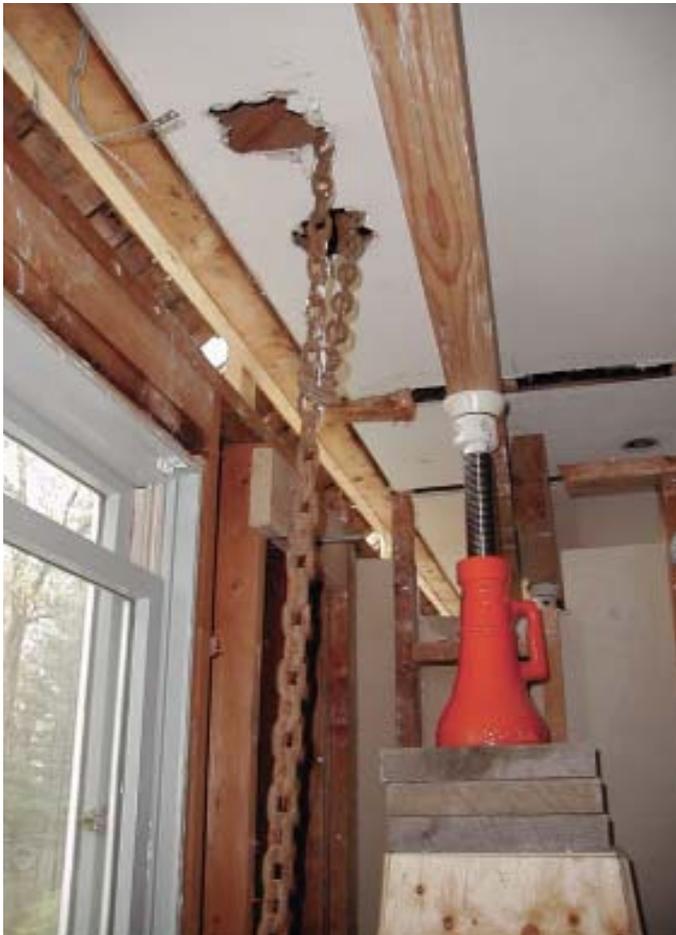
Figure 8. As a precaution against sudden strong gusts of wind, the crew tied the front and back of the house to the first story with a pair of heavy chains.

As yet another precaution, we tied the middle front and middle rear of the building's second-floor joists to the first-floor joists with heavy chains in two places. This backup system would help hold the top and

bottom portions of the house together if a sudden wind came up (Figure 8, next page).

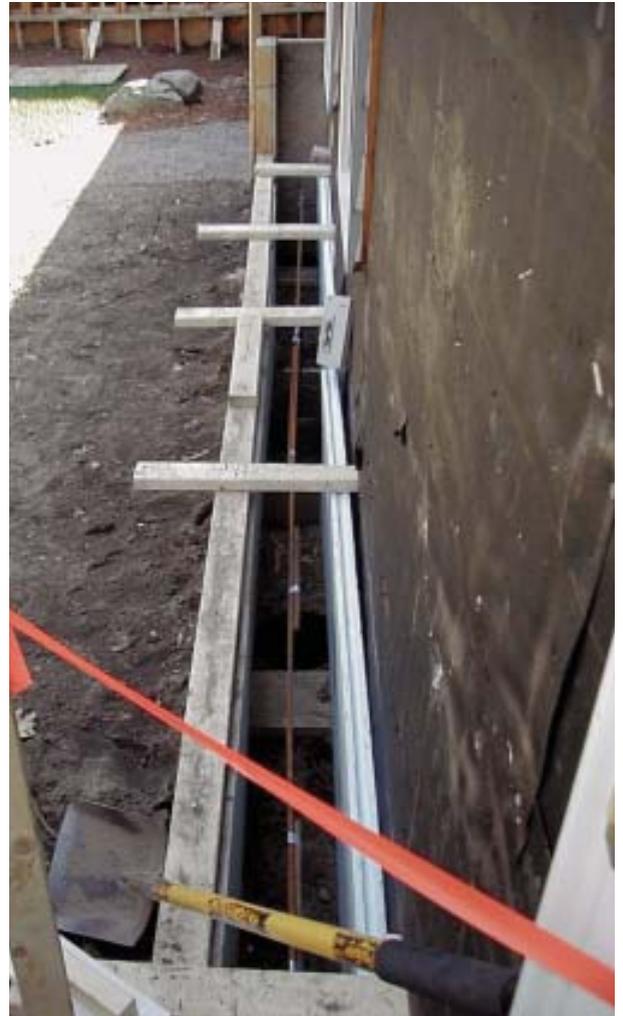
Figure 9. A new grade-beam concrete foundation, poured directly along the existing basement wall, and new wall framing provided direct support to eliminate the overhang of the second-story eaves wall.

At the front of the house, we poured a new foundation alongside the old one, filling the gap between the old and new walls with 2-inch rigid foam insulation to save on concrete, which we had to place by hand in wheelbarrows in order to protect the existing landscaping (Figure 9).

To further cut down on concrete, we formed the foundation as an 18-inch-high grade beam on top of concrete

piers placed every 4 to 5 feet. We reinforced the piers vertically with rerod bent at right angles to join the horizontal rerod we placed in the grade beam.

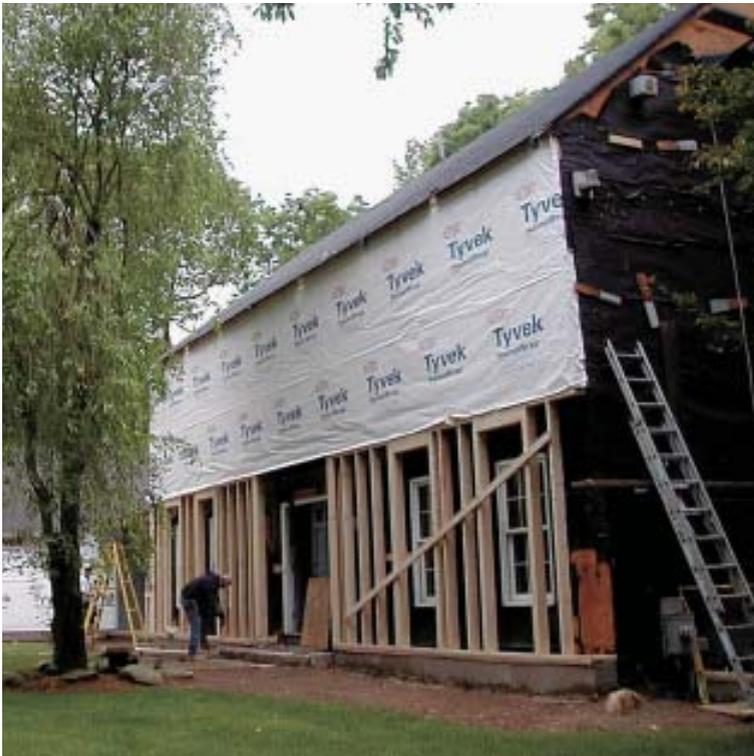
Figure 10. While the front wall went up quickly to support the building at its new height (left), the center and rear partitions had to be revised one stud at a time, by cutting and sistering in full-length studs under a new top plate. Nonbearing interior partitions were elevated with short cripple-wall sections (below).

With the second floor raised, we were able to put the new front wall in place quickly and focus on the rest of the house (Figure 10, next page).

bearing partition, we worked piecemeal. We sistered the existing studs with longer ones cut to the new height and toenailed them to a new, double top plate. Above the interior, nonbearing partitions, we simply added small knee walls to extend the tops.

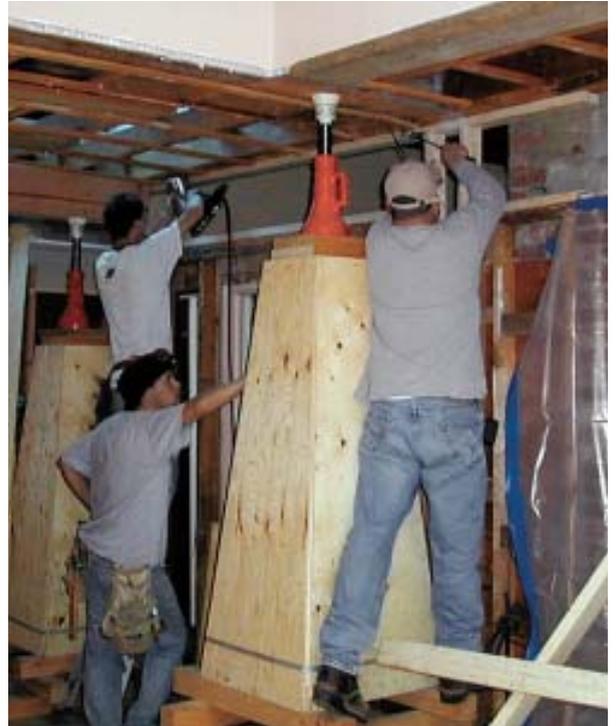
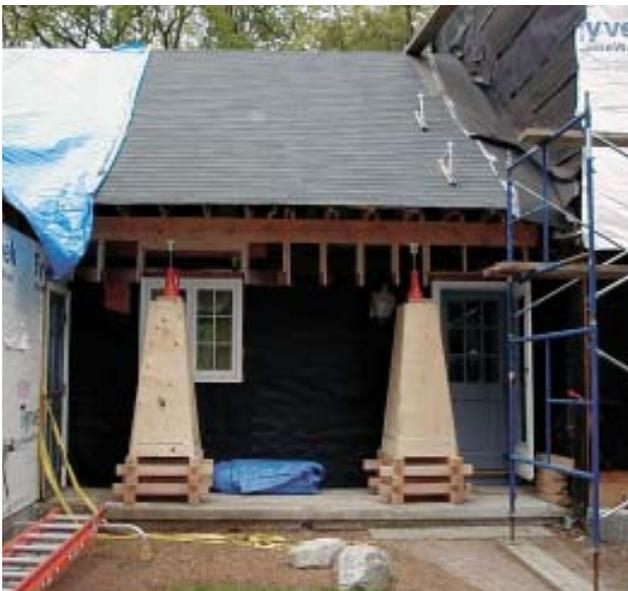
Figure 11. The screw jacks were limited to a 10-inch lifting range, so the jacking stands had to be supplemented with 4x4 cribbing placed in crosswise layers under the base.

a quantity of 16-foot 4x4s and cut them into 4-foot lengths. We used these as cribbing underneath the pyramid jacking stands. This provided a stable, strong method that could be quickly placed as needed (Figure 11).

To set the cribbing, we used a screw jack on a nearby pyramid to temporarily transfer the load. A pair of crossed 4x4s added 7 inches to the

jack-stand height, slightly more than needed to finish the job.
